FLOOD PLAIN INFORMATION

POMPESTON CREEK

BURLINGTON COUNTY

PREPARED FOR
BURLINGTON COUNTY PLANNING BOARD
AND
NEW JERSEY DEPARTMENT OF ENVIRONMENTAL PROTECTION
BY
CORPS OF ENGINEERS, U. S. ARMY
PHILADELPHIA DISTRICT
JUNE 1971

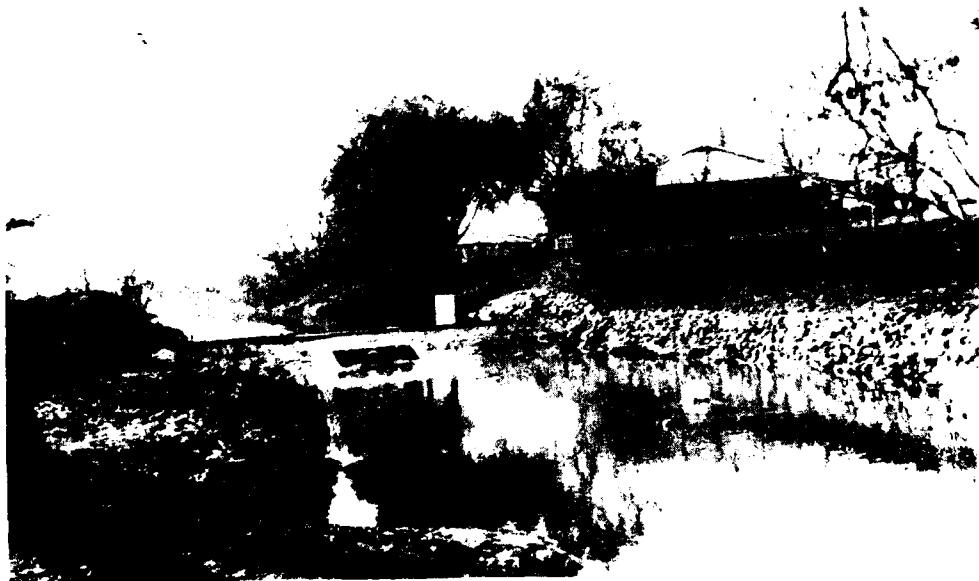
Figure 1.--DAMS ACROSS POMPESTON CREEK

Top view is the Lakeview Memorial Park Dam upstream of U. S. Rt. 130. Bottom view is the dam upstream of Riverton Road.

Two small dams are built across Pompeston Creek. The first dam is immediately upstream from the U. S. Route 130 highway bridge at the Lakeview Memorial Park. This dam has no flood control capacity and would not be restrictive for large flood flows.

The second dam is a concrete-lined earth dam with a three-foot conduit and riprapped banks. Two feet of freeboard above the top of the conduit provides flood control for minor rainfalls only. Riverton Road crosses the West Branch of Pompeston Creek 300 feet below the dam. Figure 1 shows pictures of these two dams.

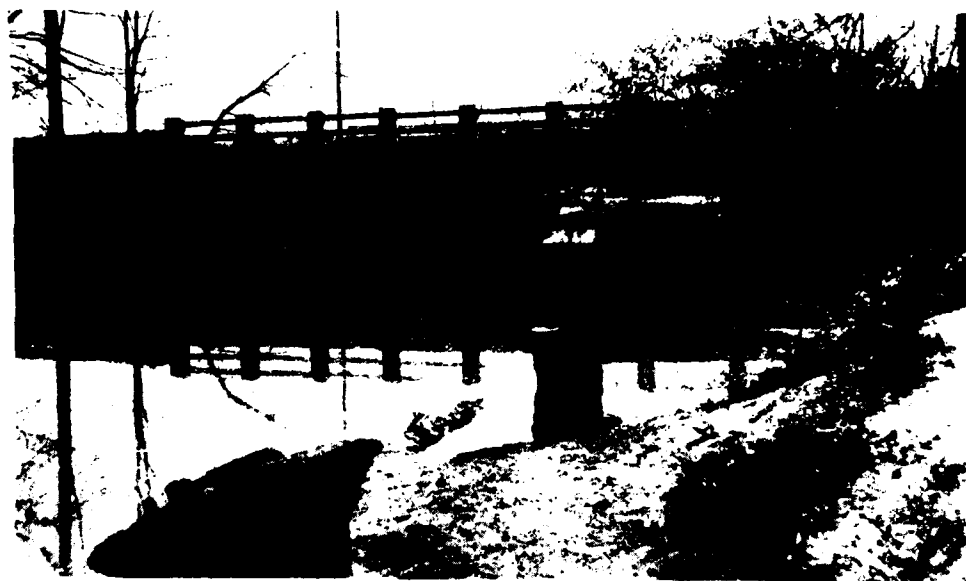
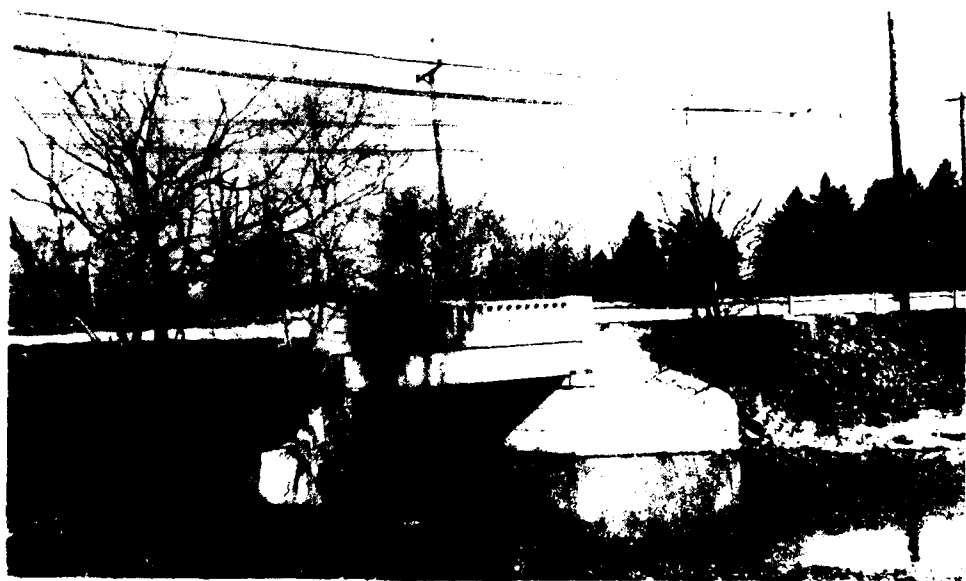
Figure 2.--BRIDGES ACROSS POMPESTON CREEK

Top view is the downstream side of North Broad Street bridge at Mile 0.3. Bottom view is the upstream side of heavily travelled U. S. Rt. 130.

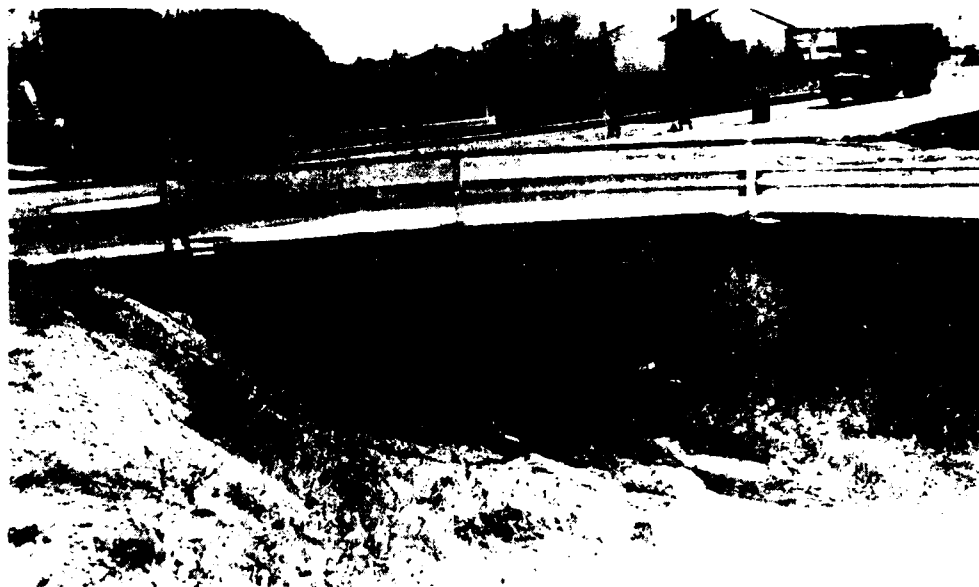
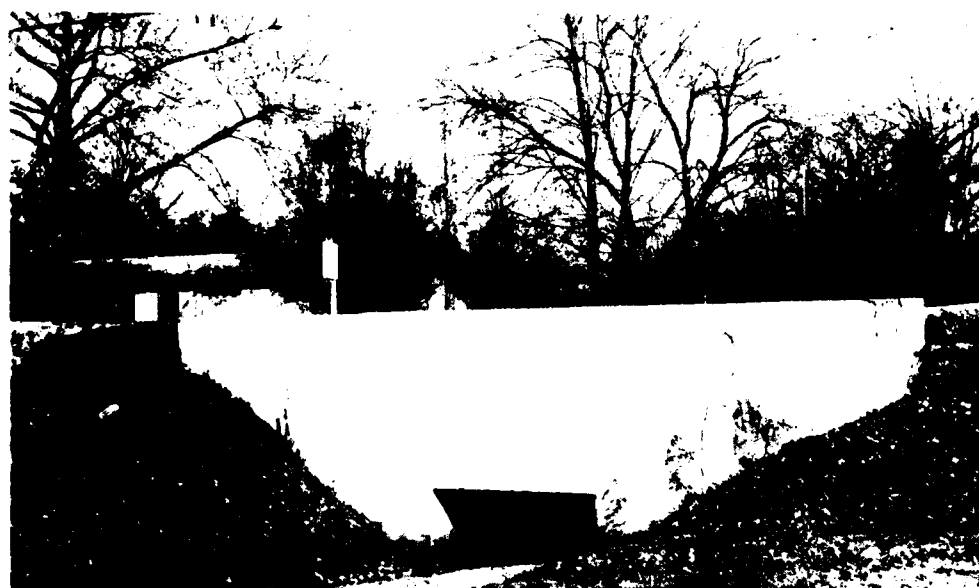
Figure 4. --BRIDGES ACROSS EAST BRANCH POMPESTON CREEK
AND JACK'S RUN

Top view is the downstream side of Parry - New Albany Road bridge at Mile 3.1. The bottom view is the downstream side of the Main Street bridge over Jack's Run at Mile 1.0.

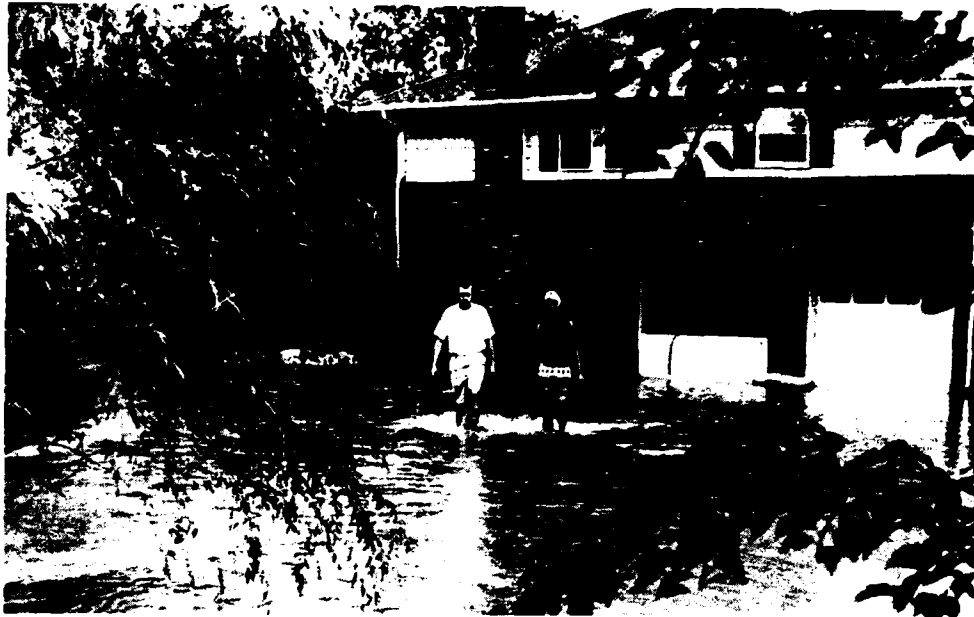
Figure 5.--NONSTRUCTURAL ALTERNATIVE

The photograph above shows portable flood shields used to prevent water from entering the garage. Simple measures such as flood shields for lower openings, check valves for basement drains and cutoff valves on sewer lines can prevent much damage to a building without detracting from the building's beauty, function or value.

Figure 5 shows the height of flooding reached during the July 30, 1970, storm by the West Branch Pompeston Creek at Devon Road. The storm was very erratic hitting Cherry Hill and Cinnaminson Townships with a deluge and sprinkling Philadelphia. Damages included flooded streets and lawns and a four-hour loss of electricity for area homes.

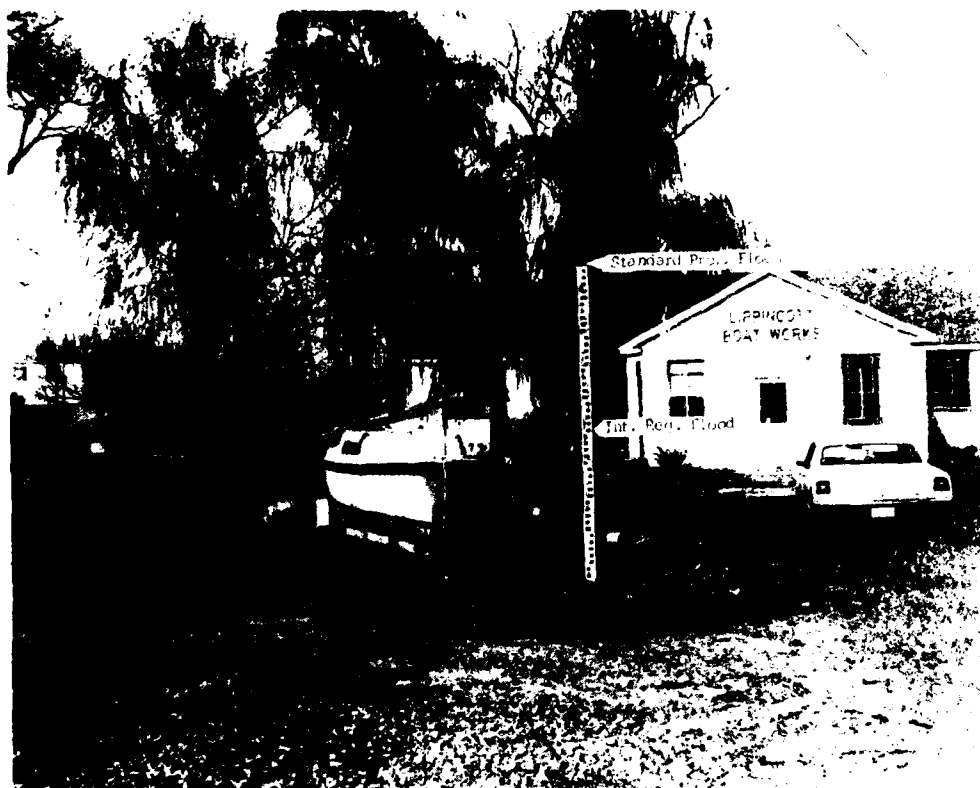
Figure 6.--FLOOD HEIGHTS ALONG POMPESTON CREEK

The arrows indicate the heights the Standard Project and the Intermediate Regional Floods would reach at the Lippincott Boat Works.
